EXPERIMENTAL MAINTENANCE PAINTING ON VARIOUS BRIDGE PROJECTS

Kentucky Highway Investigative Task 40

**Research Report
KTC-02-06/KH40-02-1F**

**Experimental Maintenance Painting on
Various Bridge Projects**

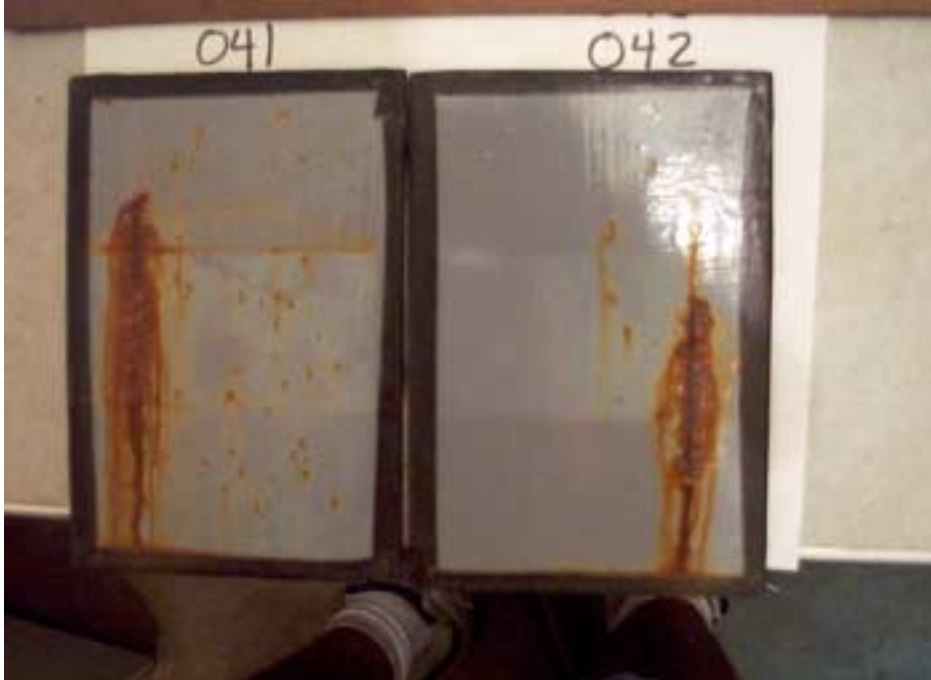
The tests were run for seven 6-week intervals (7,056 hours). In part, the extended duration of those tests was due to the desire of KYTC and KTC personnel to gain familiarity with the procedure. No endpoints for coatings failure were established. Typically, the coatings on the panels possessed significant degradation after 7,056 hours of testing (Figure 8).

Figure 8. Typical panels after 7,056 hours of accelerated weathering and corrosion testing.

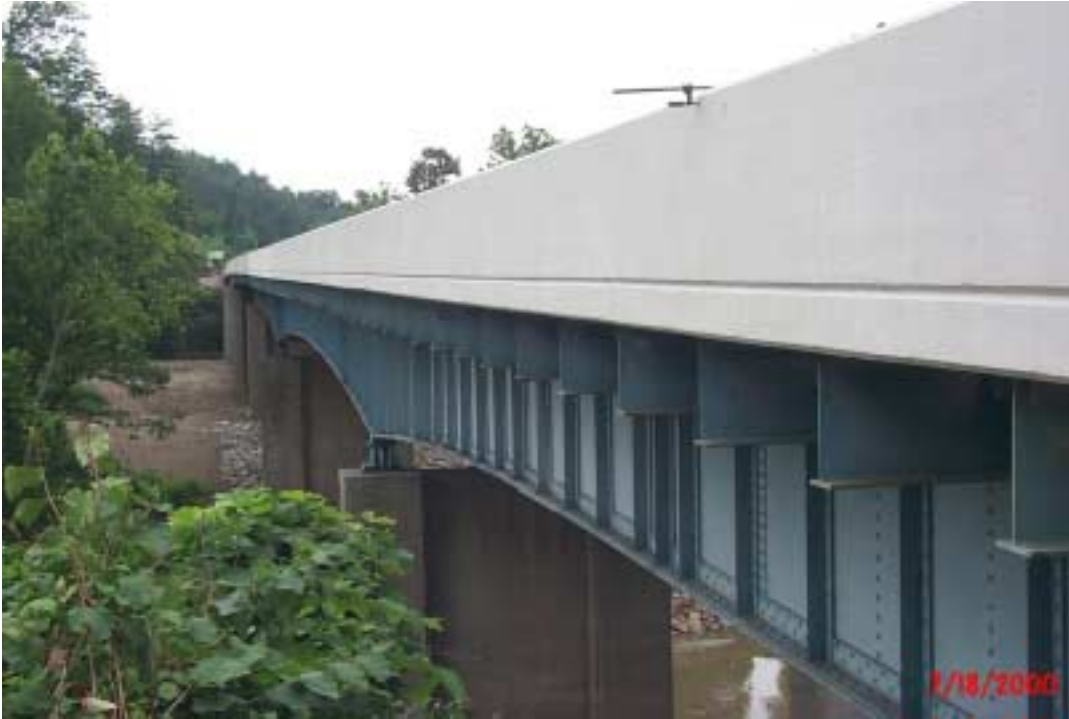
Figure 24. The condition of north face of the existing bridge prior to the onset of work.

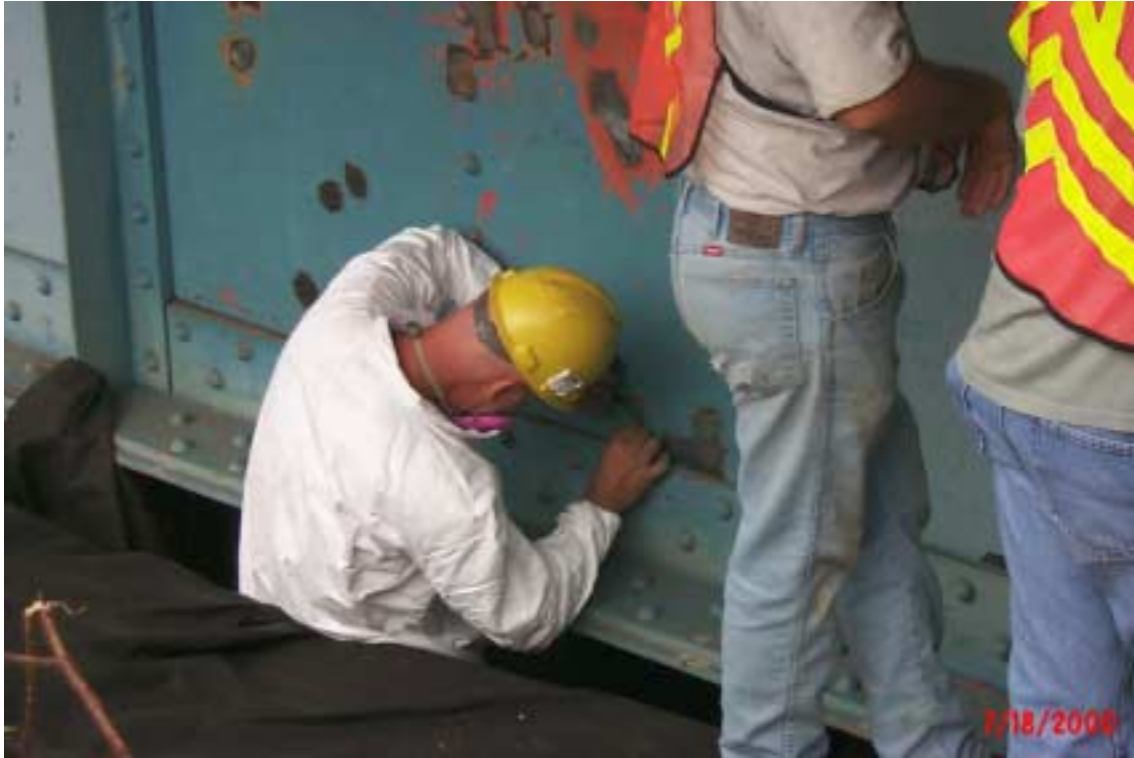
The Special Notes and Standard Specifications were not followed entirely during the cleaning and painting of bridge. Lifted edges of overcoated paint and rust in Tooke cuts indicated that an SP11 surface finish was not obtained during cleaning of bridge. There should have been no rusted substrates when the new coatings were applied and exposed edges of existing paint should have been feathered to prevent lifting.

Figure 30. A worker feathering of exposed edges of existing paint with putty knife.

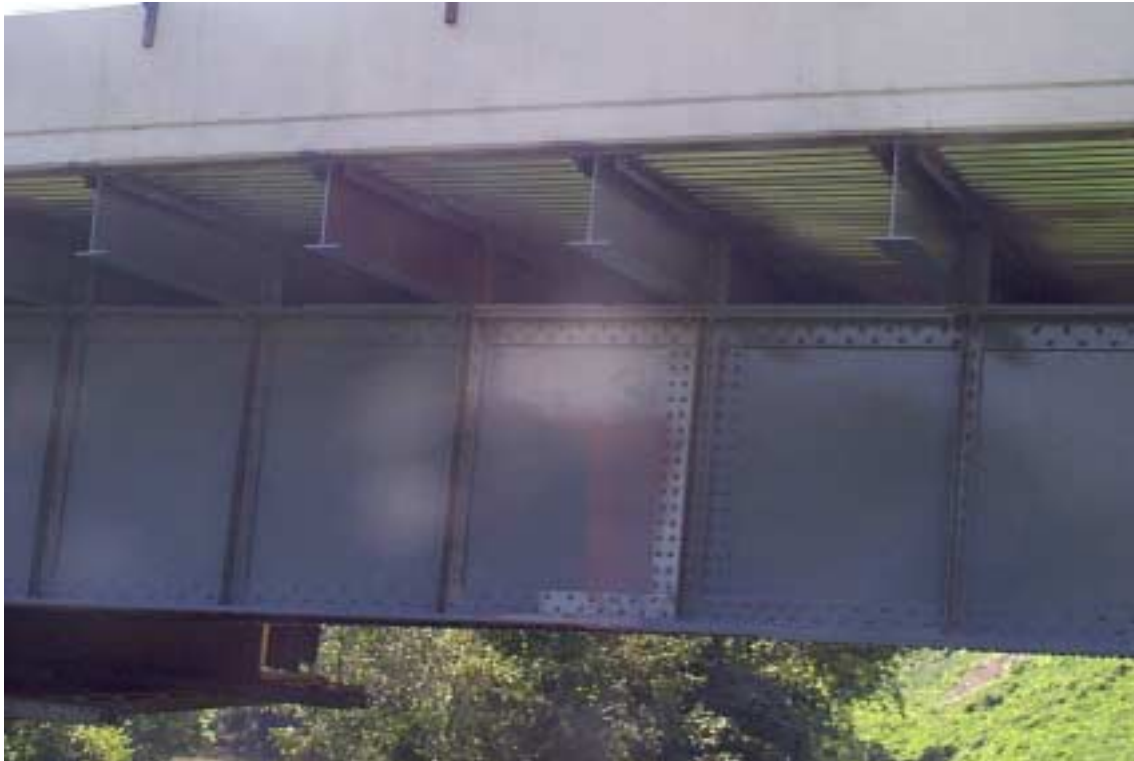
The final inspection was conducted on June 19, 2000. Most of the work was deemed satisfactory. The inspection revealed pinholes, cracks, blisters, runs, and misses that were to be eliminated as part of a corrective work punch list.

Figure 31. The completed experimental coating during the final inspection of the bridge.

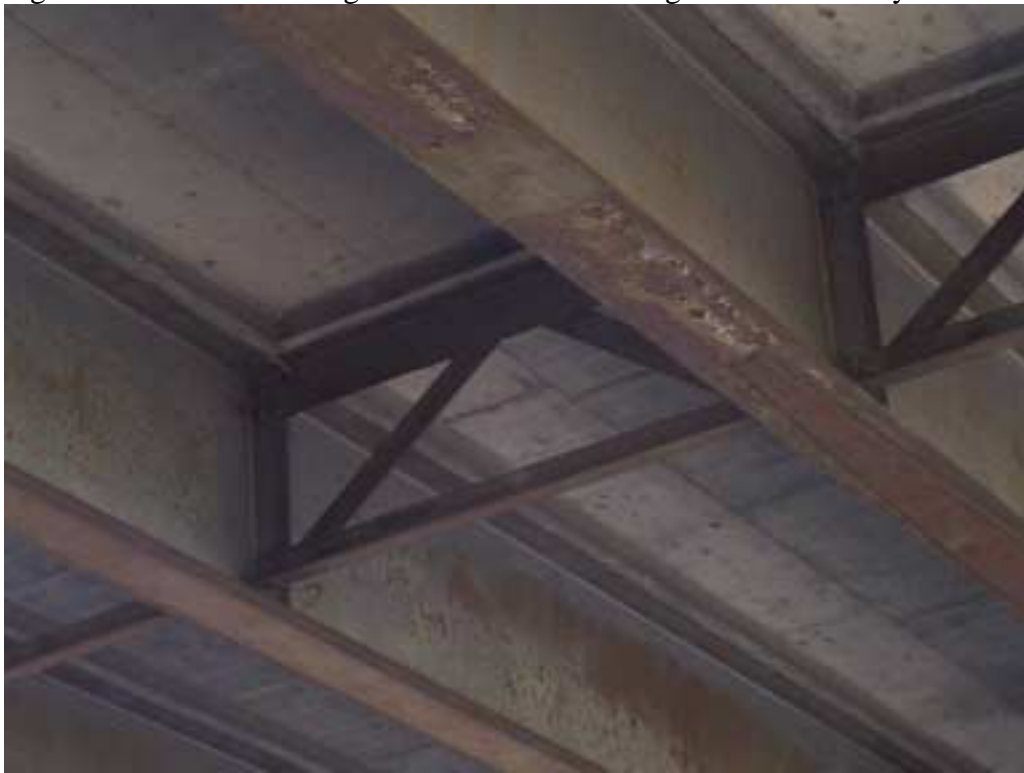
The existing coating included a red-lead primer with one coat of leafing aluminum intermediate and one coat of nonleafing aluminum top coat. The existing coating was severely deteriorated with rust on 15-20 % of the surface.

Figure 34. The condition of the existing paint on the bridge prior to painting operations.

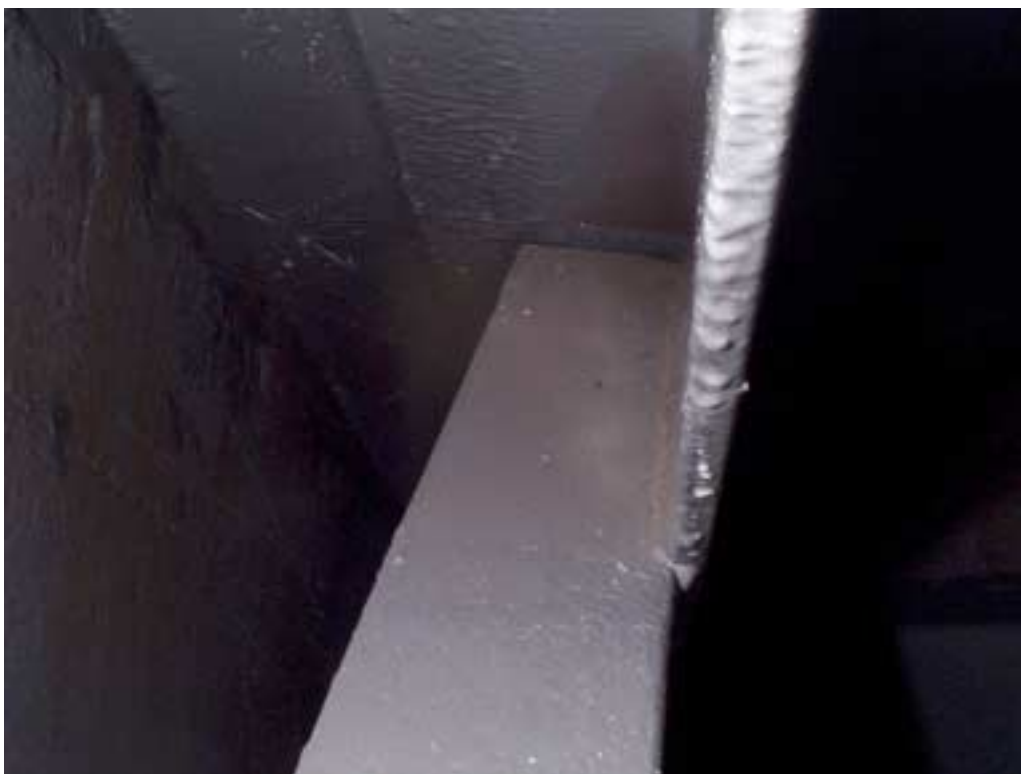
East End Numerous pinhole areas were present, topcoat was missing on bolts at a rocker and on the backside of abutment diaphragm (3).

Figure 35. The back face of an abutment diaphragm showing a lack of topcoat.

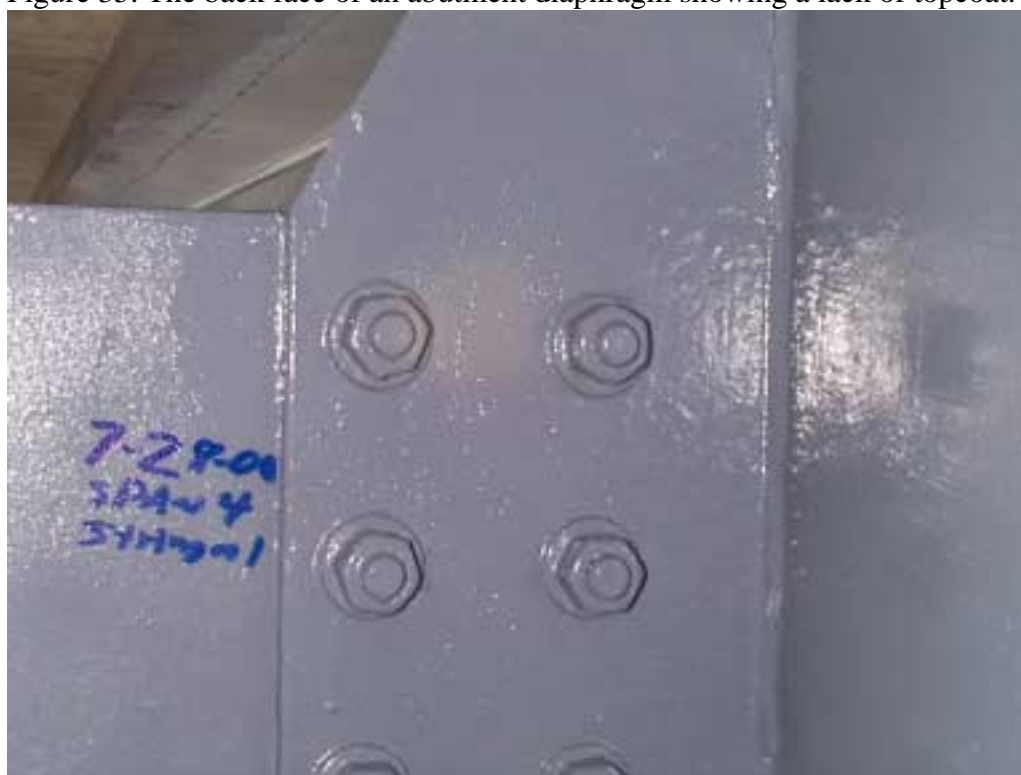
The follow-on inspection of Spans 1 and 4 revealed pinholes, cracks and bubbles over most steel in both spans. Those areas were noted in the final inspection but were not corrected. Tooke tests indicated excessive thickness of the topcoat in two areas. There were many areas with visible red lead. As a consequence of the contractor's failure to follow the contract requirements, this project is not in conformance with the Special Notes and Standard Specifications.

Figure 36. Pinholes and bubbles were observed in the new coating throughout the bridge.

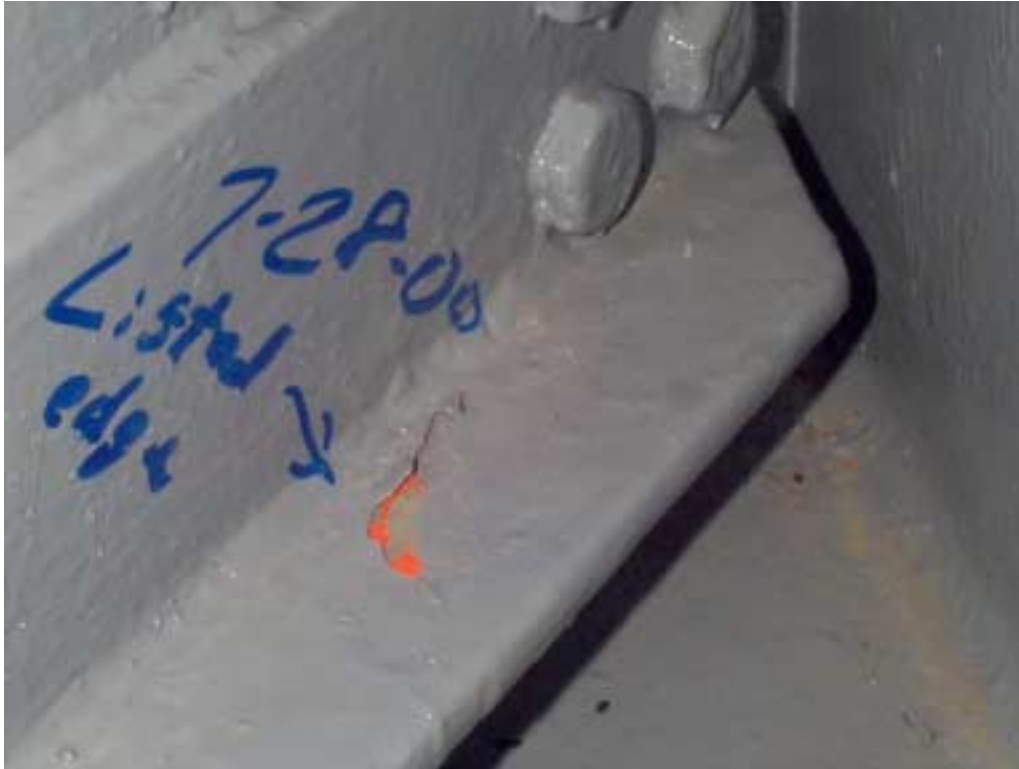
The Special Notes and Standard Specifications were not followed throughout the cleaning and painting of this bridge. Lifted edges of paint detected in Spans 1 and 4 indicate that the specified SP11 cleaning was not obtained. Rust detected in Tooke cuts also indicates that cleaning of bridge was not performed properly.

Figure 37. Lifted edges of existing paint at a diaphragm.

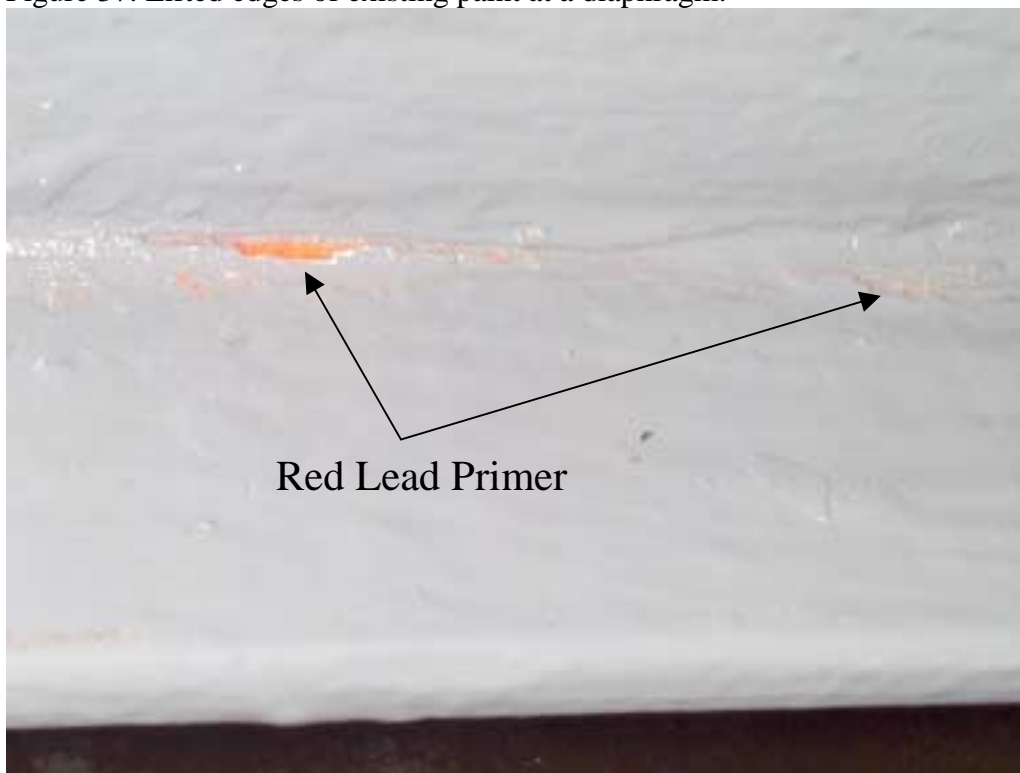
Figure 38. Exposed red lead on an abutment diaphragm.

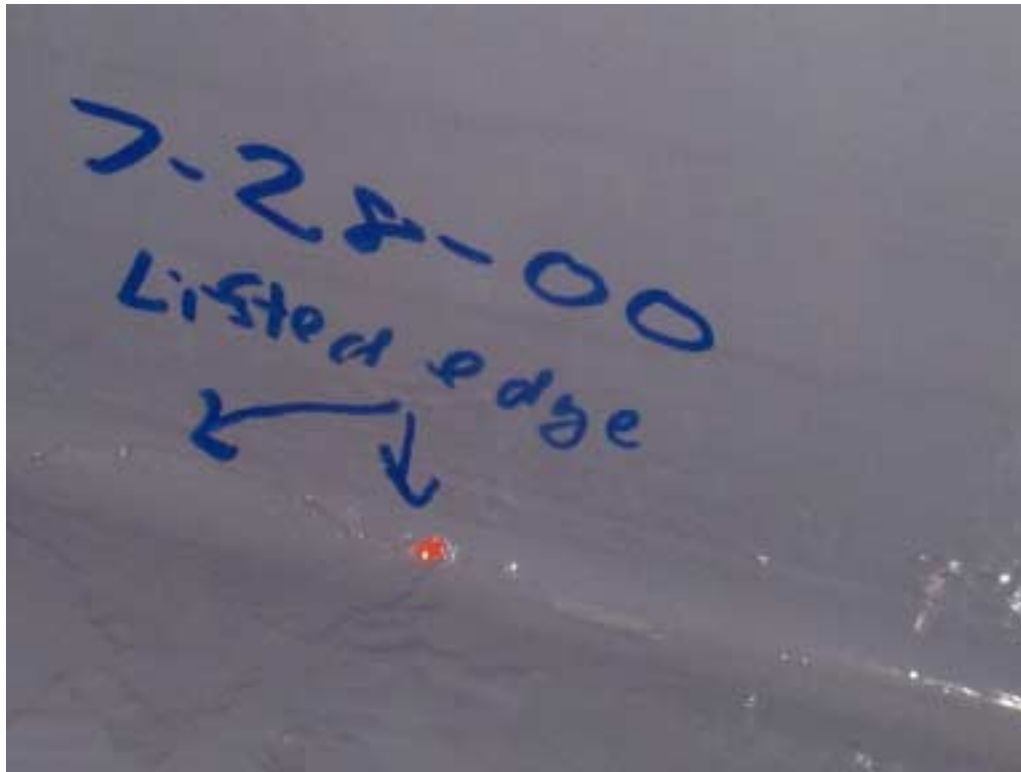
Figure 39. Exposed red lead and a lifted paint edge at the corner of a bottom flange.

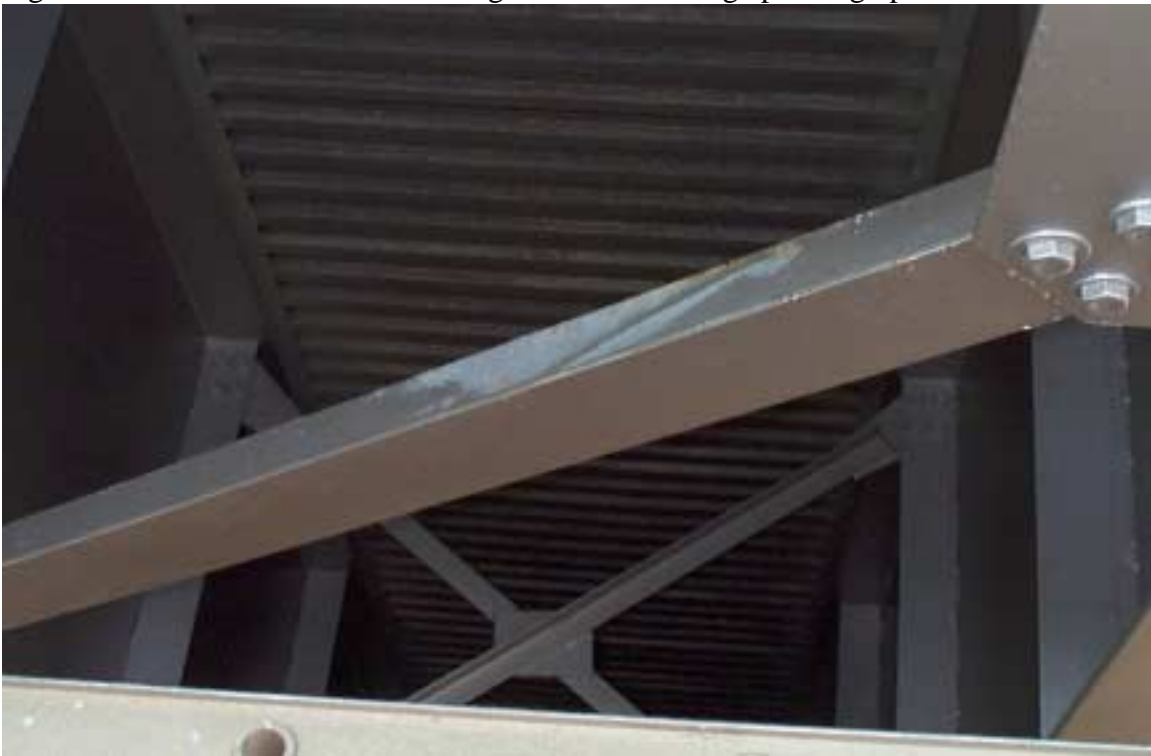
The defects and poor workmanship encountered on this project were not serious when considered individually. Their frequency and extent throughout this bridge however sum up to, at best, a marginal product that should not be countenanced in the future. The fact that this was an experimental maintenance painting project using a new coating system warrant that it be considered a failure for the purposes of a proper evaluation of that system.

Figure 45. An example of areas the contractor missed during painting operations.

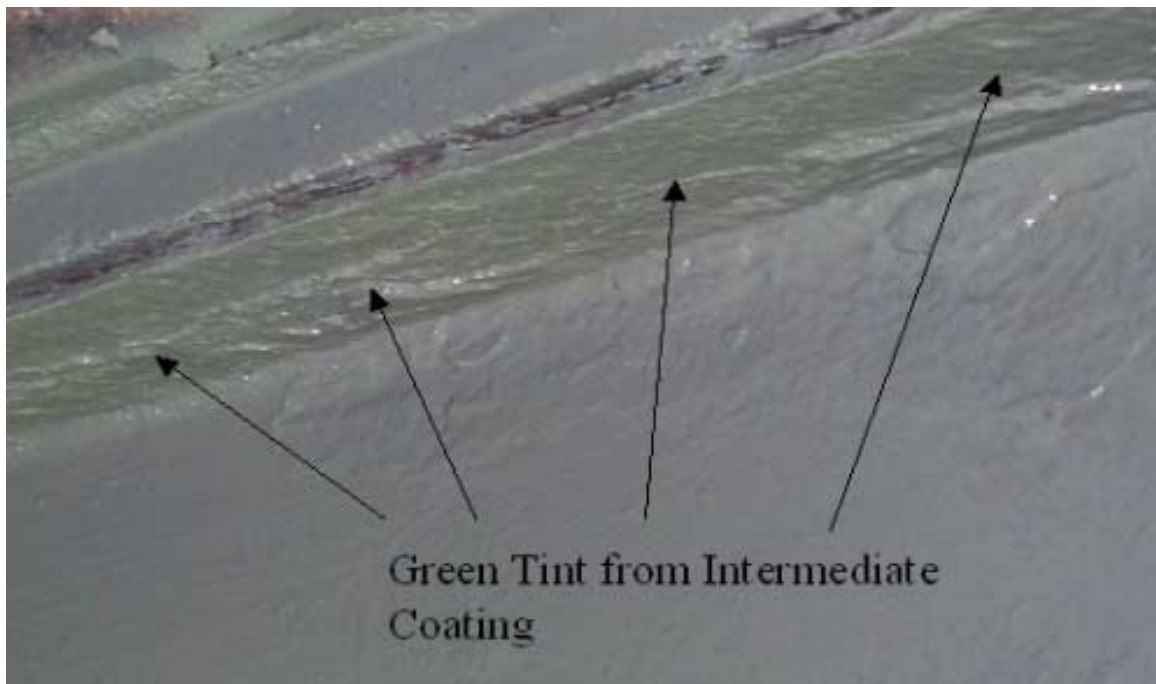
This project is unusual in that above the normal workmanship issues of inadequate surface preparation, coating misses, and improper coating thicknesses is the abysmal appearance of the finished product. It is fortunate that this bridge is in a remote area and will not be widely viewed by the public. Otherwise, it would provide a poor image of KYTC ability, concern and effectiveness to the general public.

Figure 46. Green-Tinted intermediate coat visible through a thinly applied topcoat.

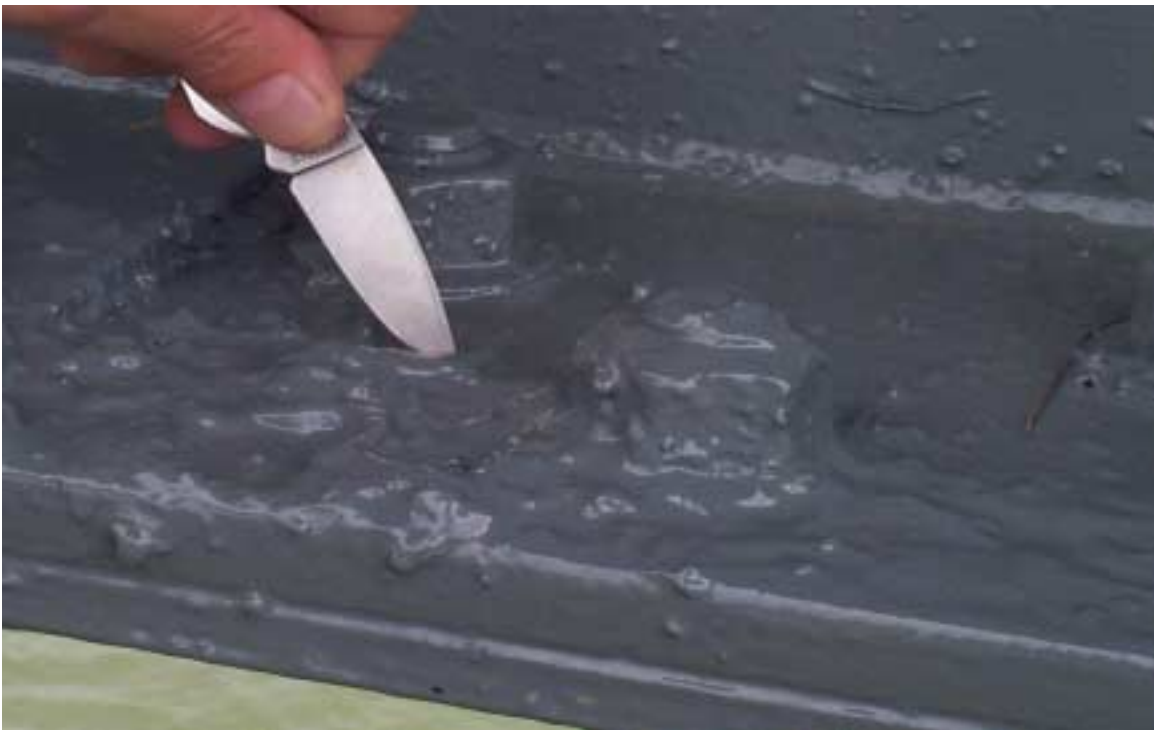
Figure 47. A location where new paint had been applied over pack rust.

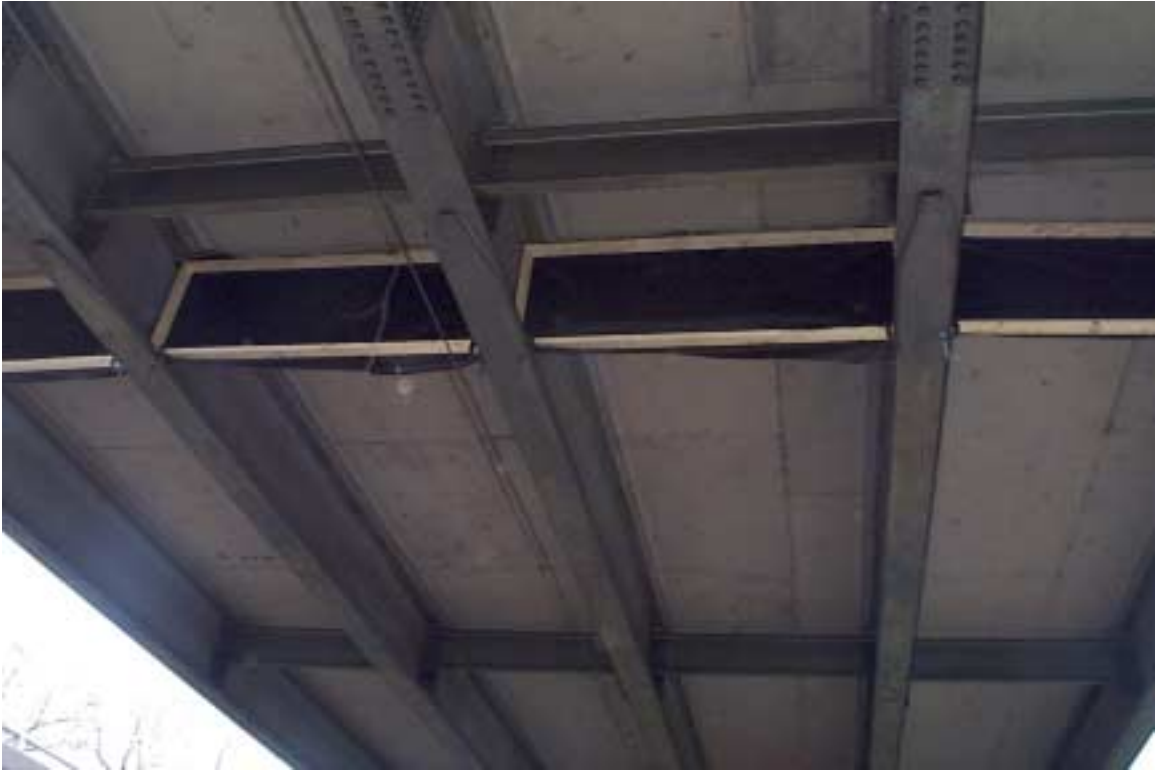
Figure 50. The condition of the existing coating prior to painting operations.

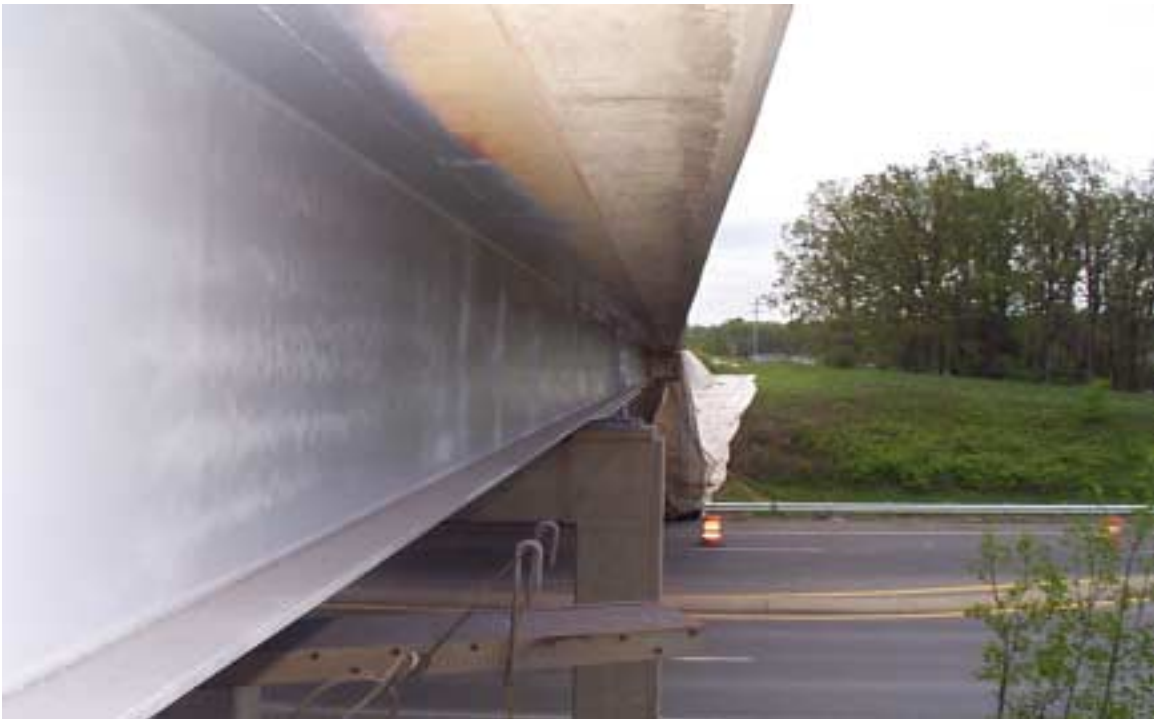
Figure 53. The mottled appearance of the topcoat alternating between flat and glossy finishes.

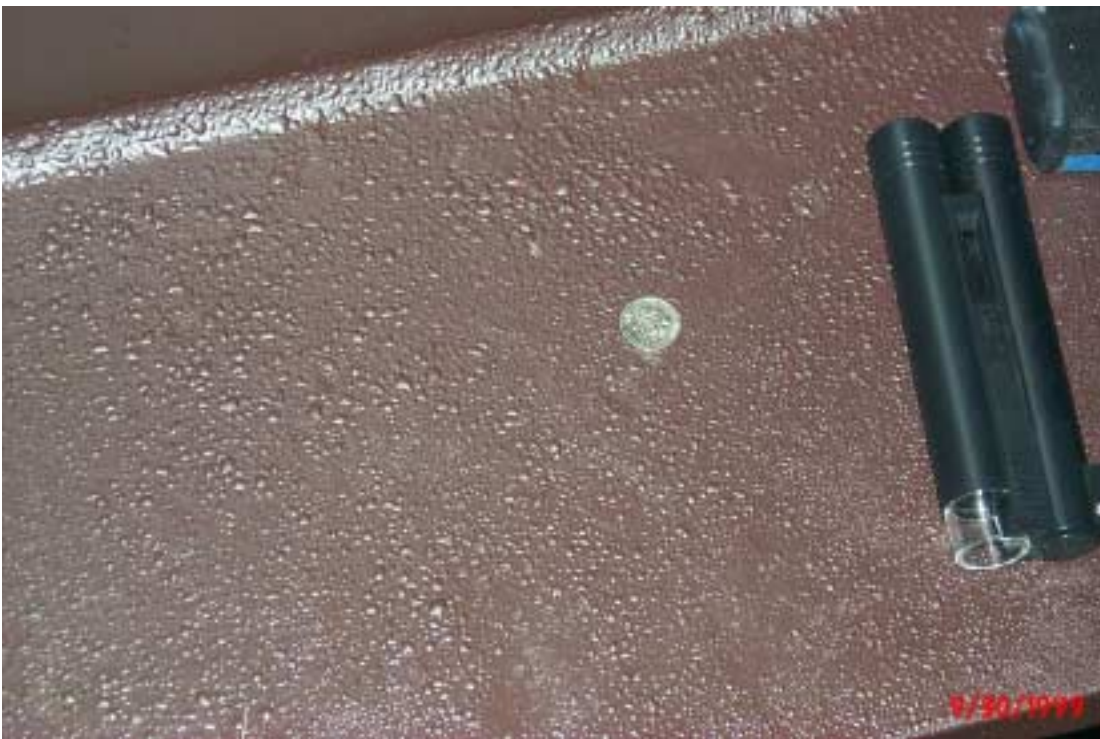
Figure 59. Blistering of the MIO intermediate coating during test patch application.

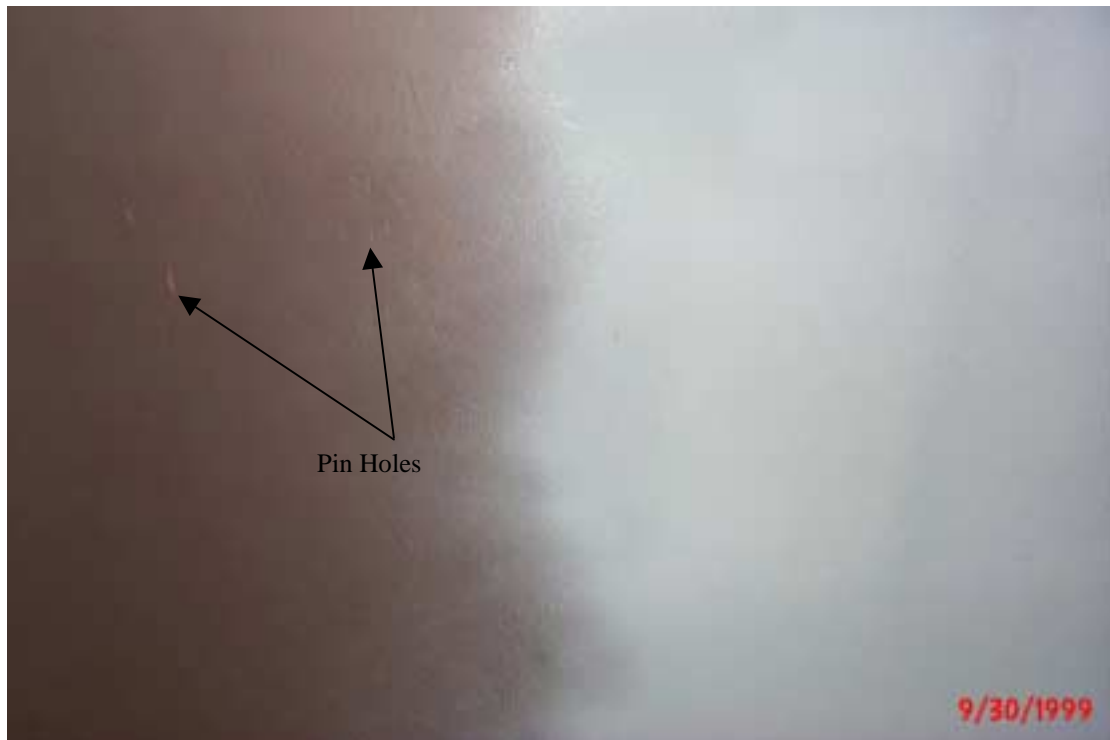
Figure 60. Pinholes in the intermediate coating after the test patch was applied.

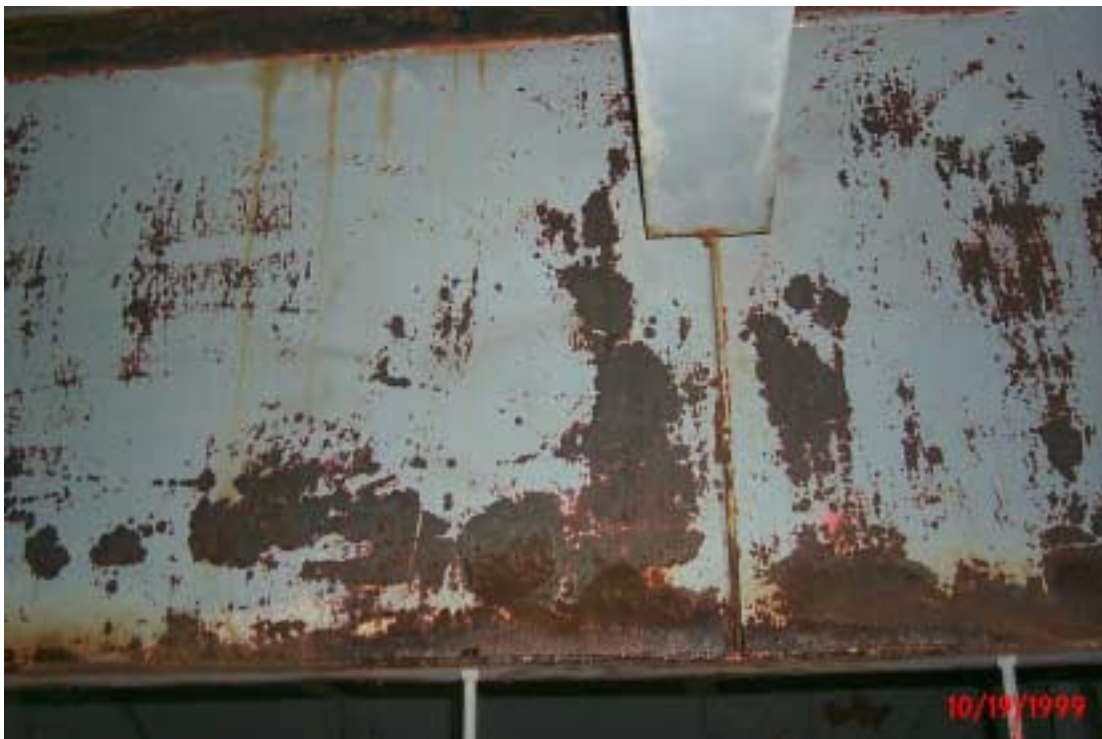
Figure 61. Mill scale on steel exposed after pressure washing at 7,000 psi.

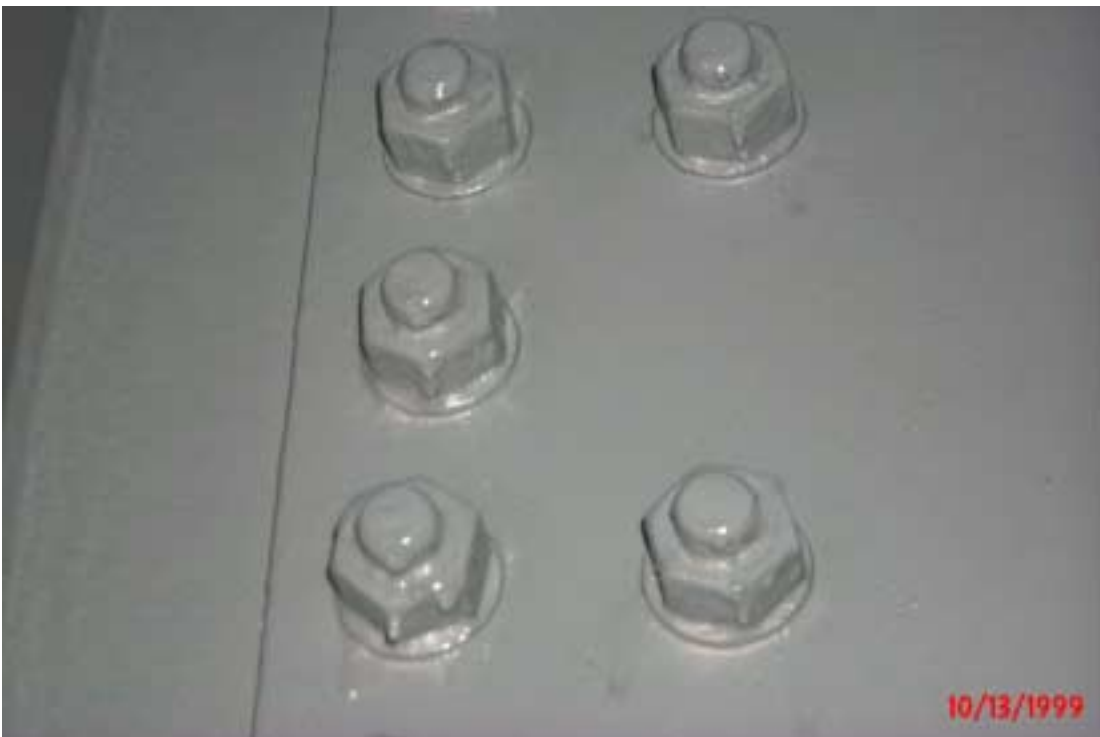
Figure 63. Excessive paint applied to the to fasteners.

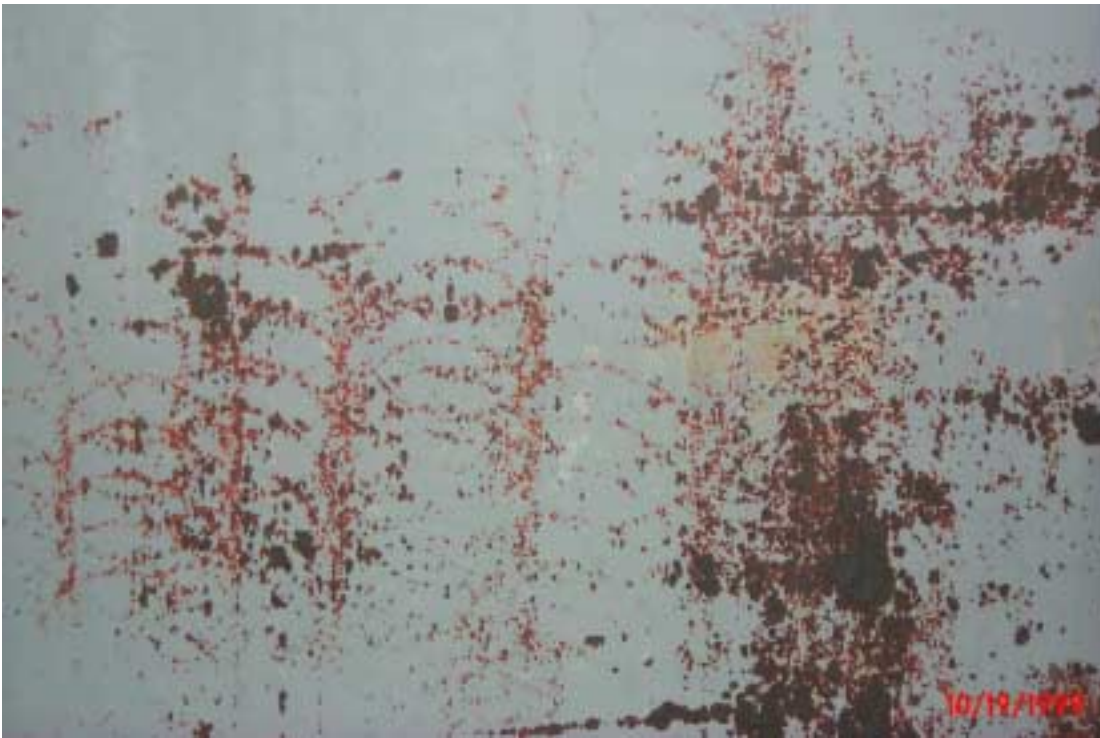
Figure 65. Visible swirl lines cut into the existing paint after pressure washing with a 0° spinner tip
